Interchangeable Body System,
specially developed by EMPL

Safety Tests on the EMPL troop carriers
equipped with special safety seats

Empl Interchangeable Body System

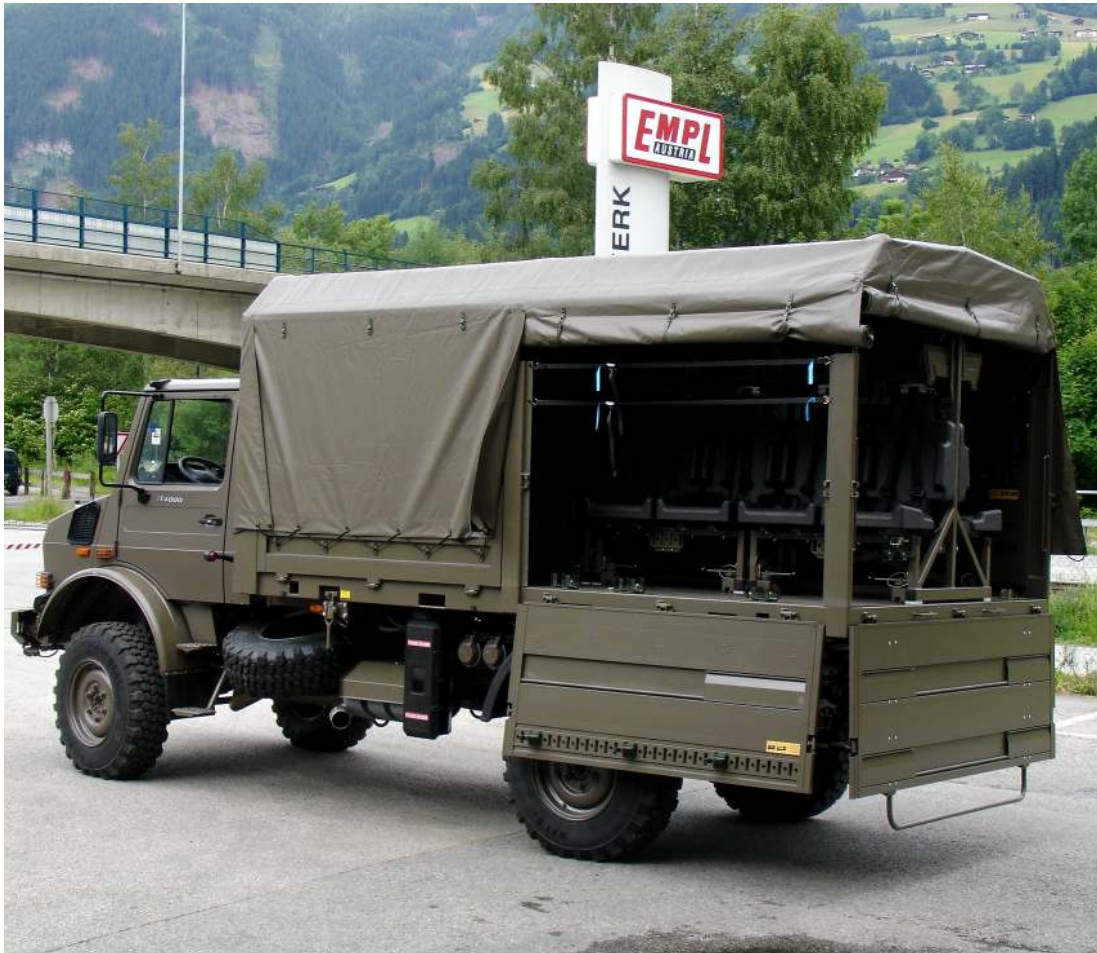
Fig. 1: Chassis with interchangeable body

- Tested Vehicle
 - Interchangeable Body, type "Troop Carrier", mounted on a Torsion free sub frame and equipped with specially developed Safety seats, as ordered in a huge quantity by the Austrian Armed Forces (Fig.1)

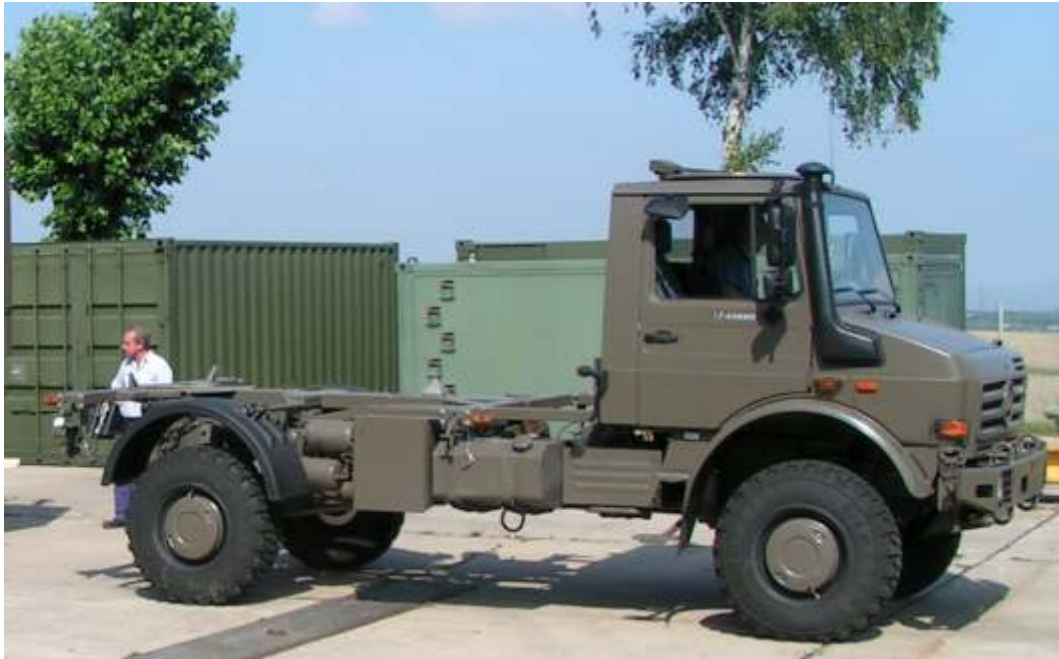
Fig. 2: Vehicle with torsion free subframe

- Main Points of inspection
 - Stability of the connection elements "torsion free sub frame & chassis" (Fig. 2)
 - Stability of the locking mechanism "subframe & interchangeable body" (Fig. 3)
 - Stabilität der Verankerungen der Sicherheits-Sitzmodule im Pritschen-Boden (Abb. 4)
 - Stability of the connection elements "safety seat module & body floor" (Fig. 4)
 - Overall stability of body (side wall, front wall, stanchion, tarpaulin frame), regardless if mounted fixed or interchangeable.

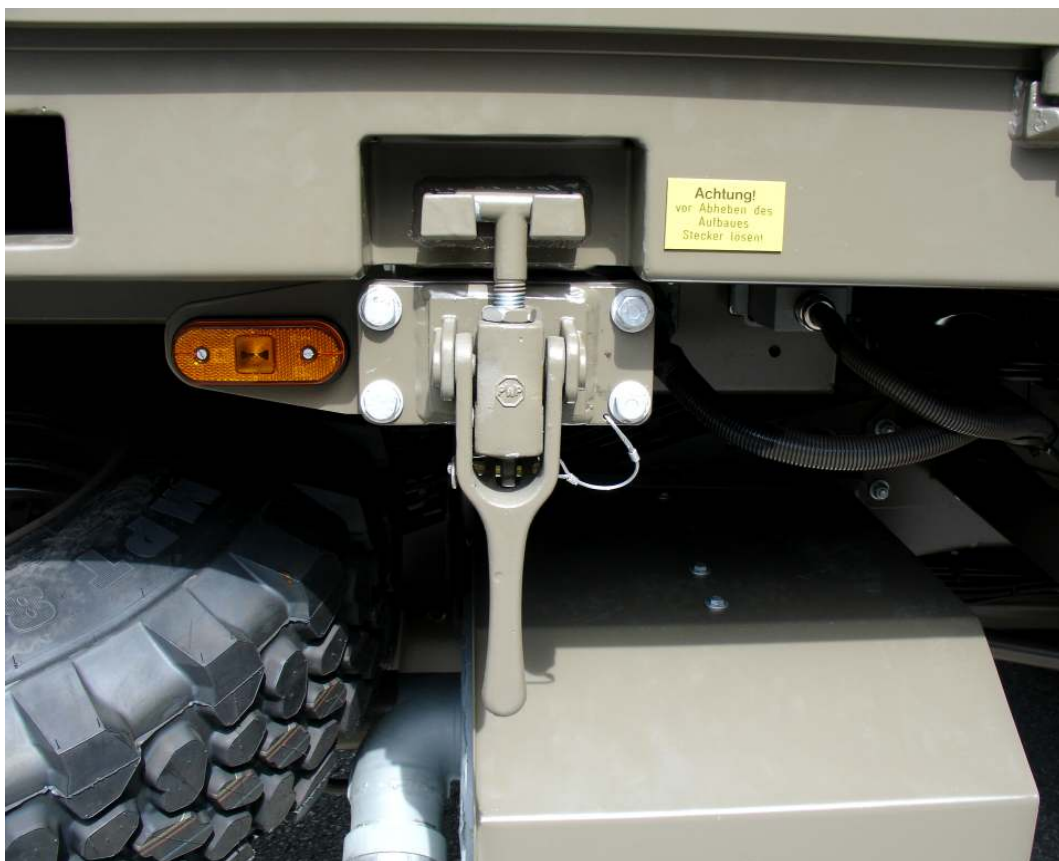
Fig. 3: Locking mechanism for interchangeable body

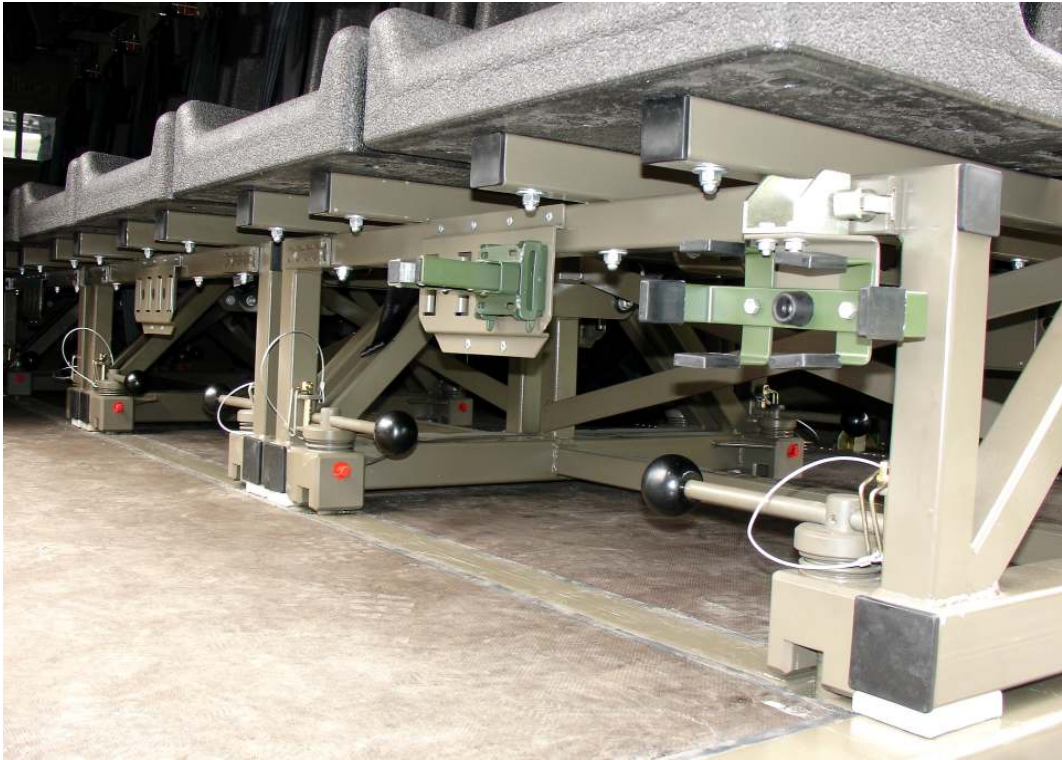
Fig. 4: Elements bracing the EMPL safety seat module on

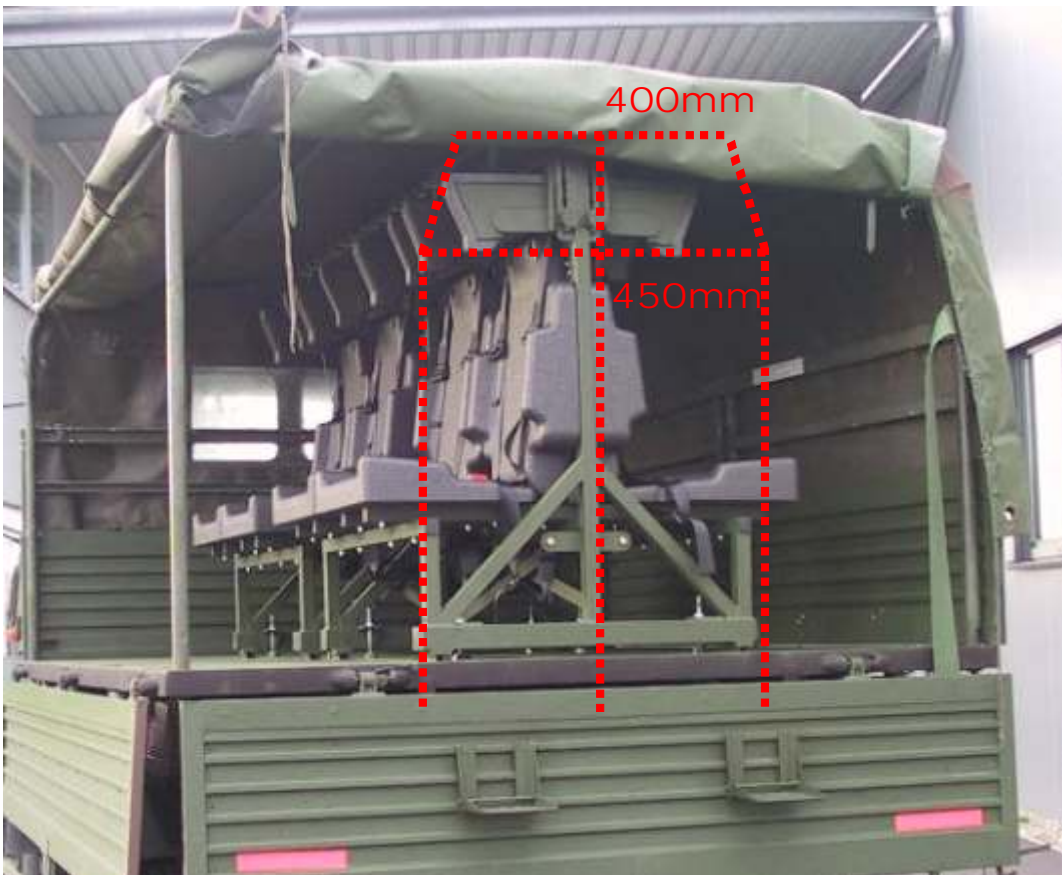
Fig. 5: Defined survival space in the EMPL safety seat module

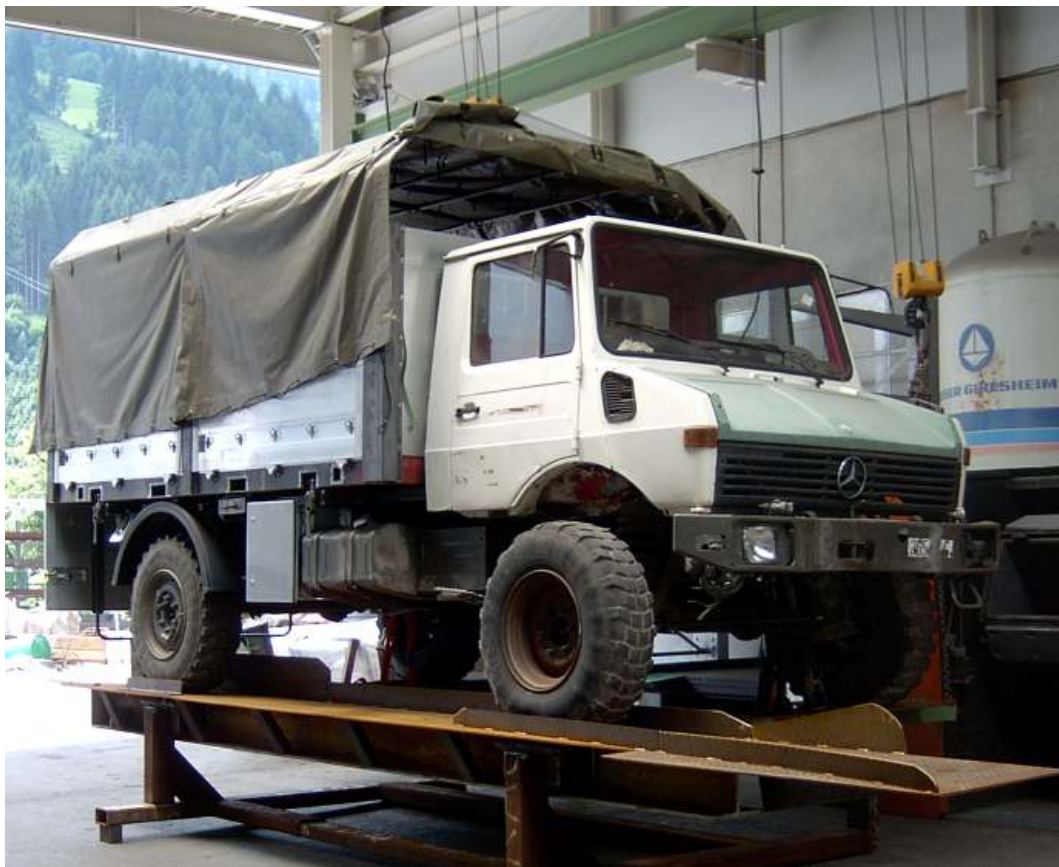
Fig. 6: Test Vehicle UNIMOG 425

- Tested Chassis
DC UNIMOG Type 425 T including
D65 (Fig. 6)
- Conducted modifications
Enlargement of the wheelbase by
600 mm, corresponding to U4000
- Body
out of series production (order of Austrian Armed Forces)

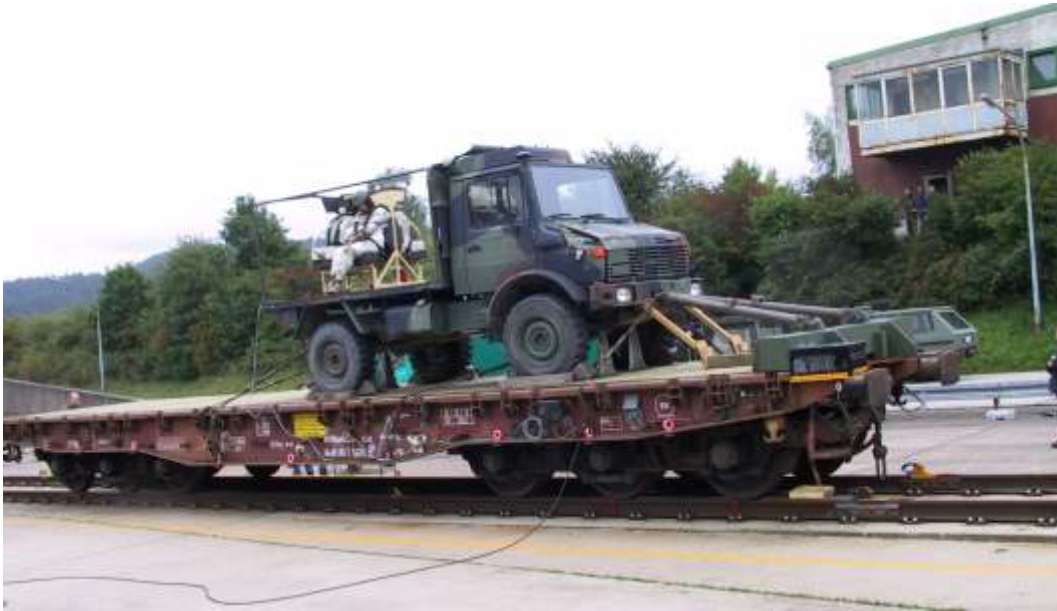
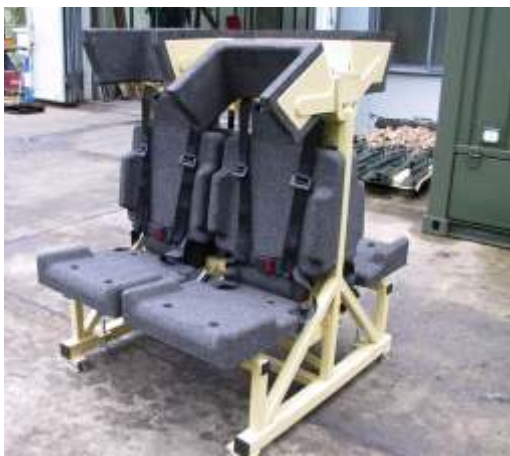
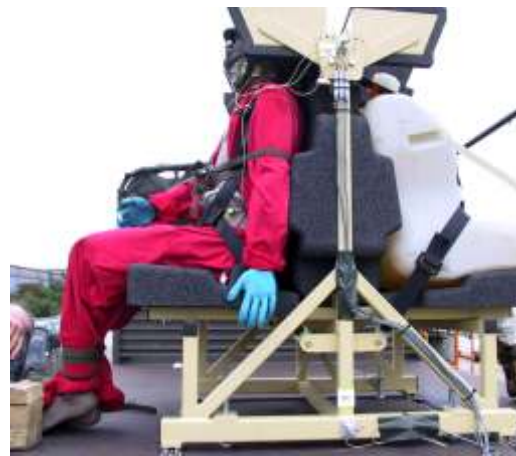
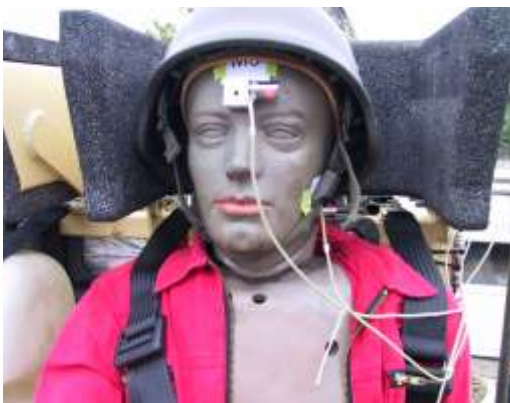
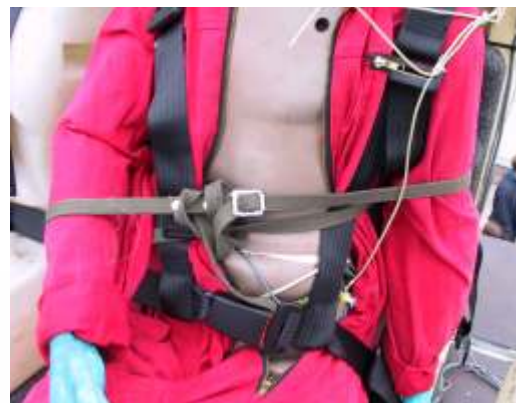
Fig. 7-11: Frontal Crash-Test in Trier

The safety seat module specially developed by EMPL was successfully tested in 2001 in the WTD 41, the testing facility of the German Army in Trier. (Frontal crash test when driving 50 km/h)

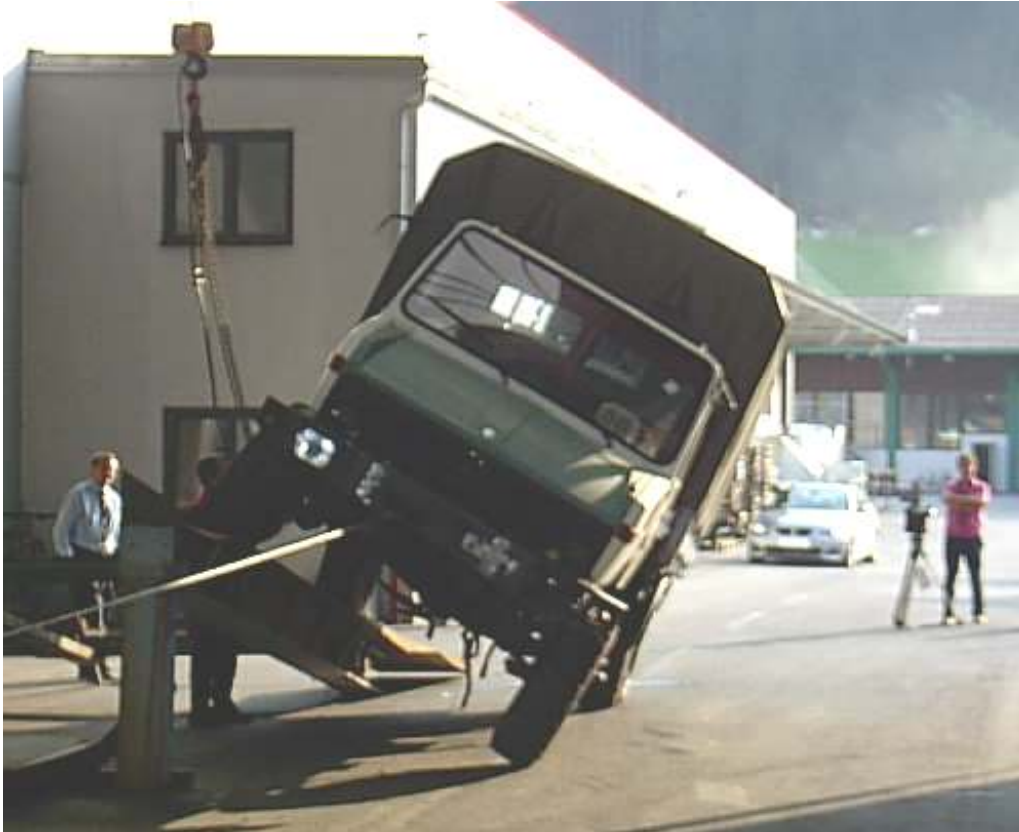
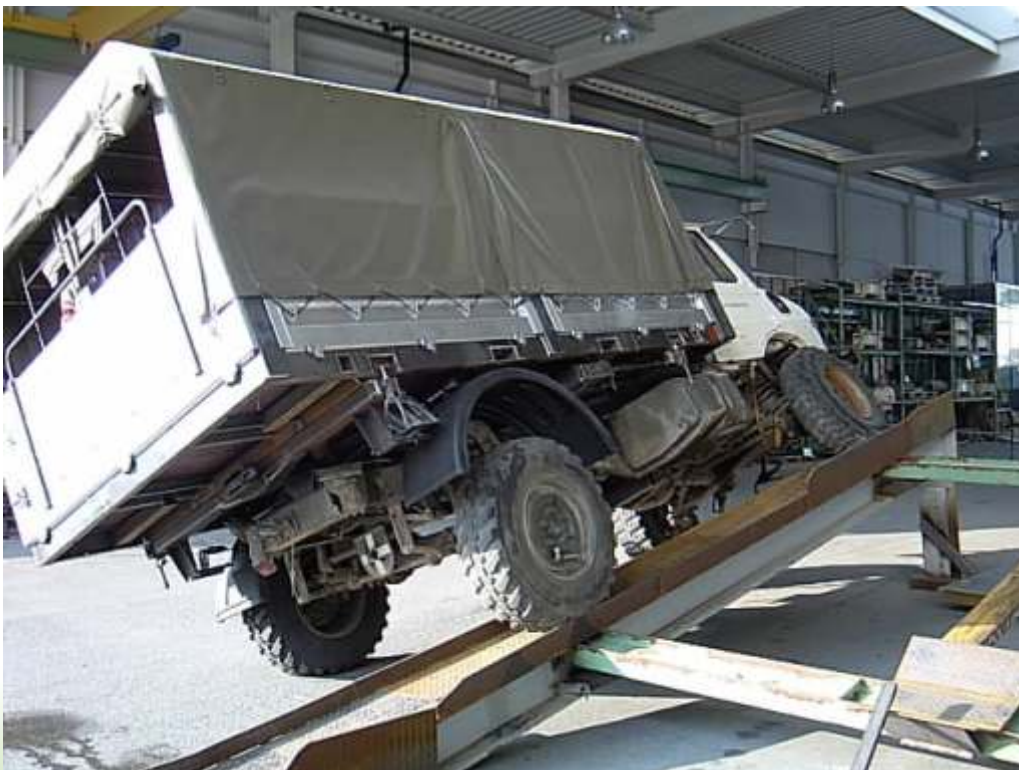
Fig. 12 & 13: Test 1 – Front & rear View

With the help of a winch, the UNIMOG (unfit to drive) is pulled with 20 km/h over a ramp until the vehicle tips over (Fig. 12 & 13)

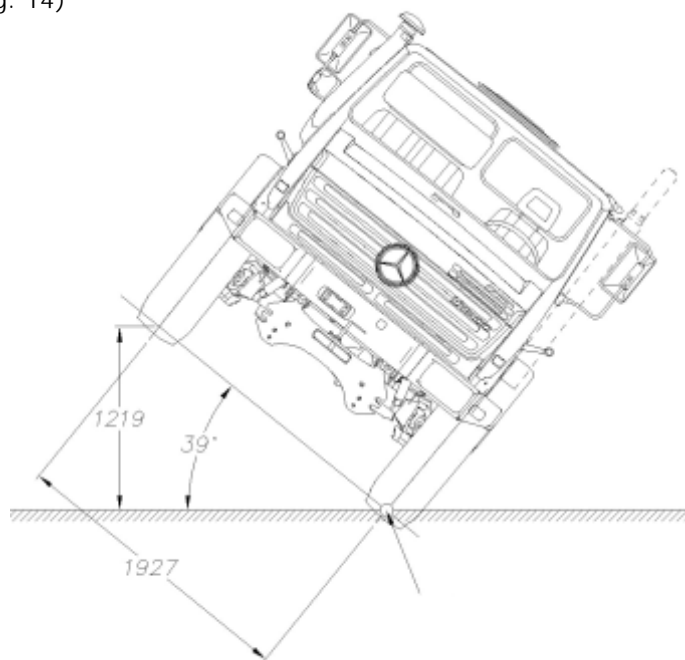
Fig. 14: Test 1 – Vehicle at pivotal point

- Results
The UNIMOG tipped over at a slope of approx. 39° (Fig. 14)

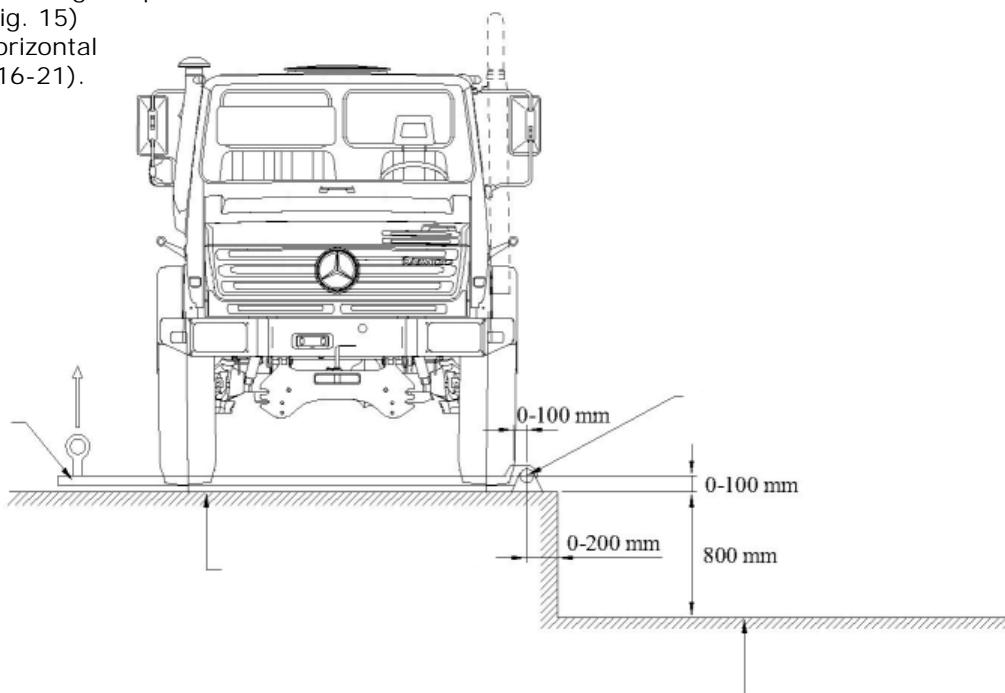
Fig. 15: Test 2 – Test Arrangement

- Procedure
The Vehicle is positioned on a tilting ramp (with a height of 800mm) (Fig. 15) and is tilted side way on a horizontal hard surface (asphalt) (Fig. 16-21).

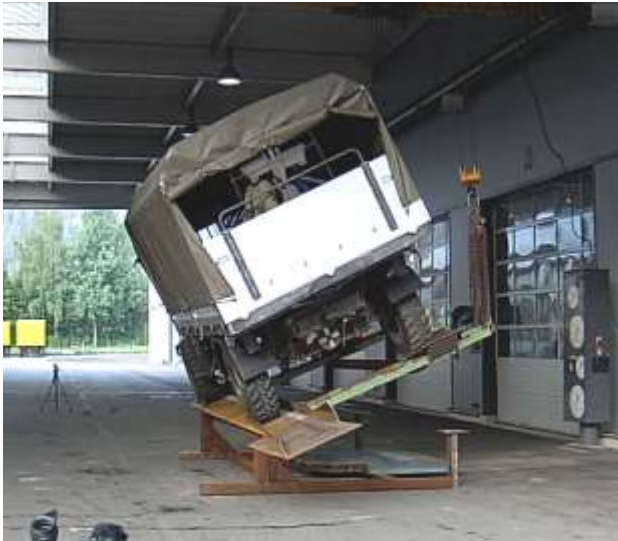
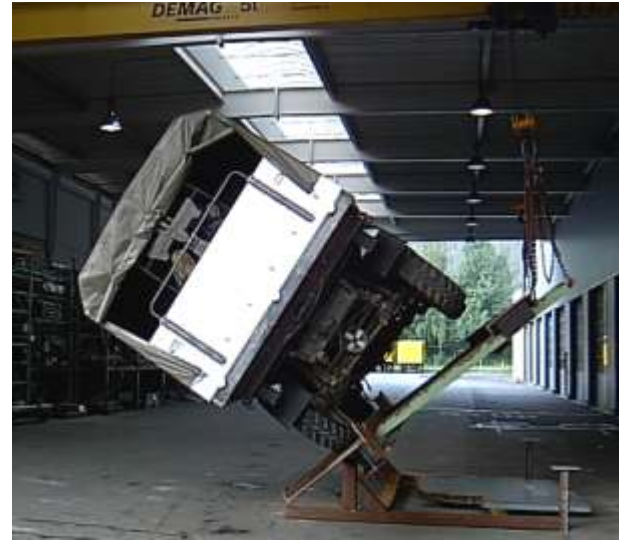
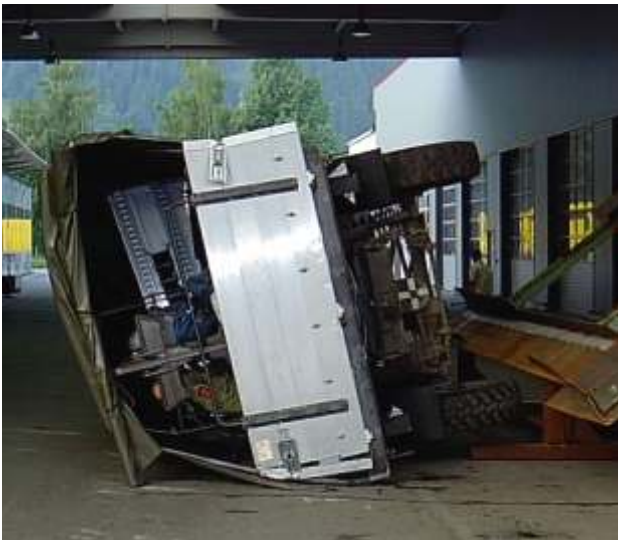
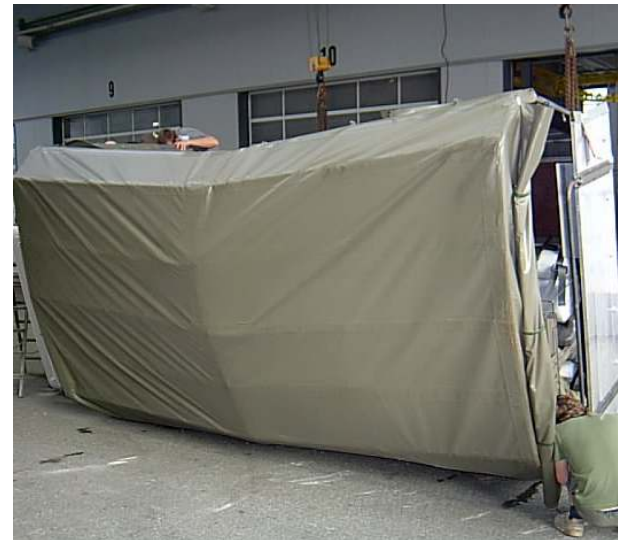
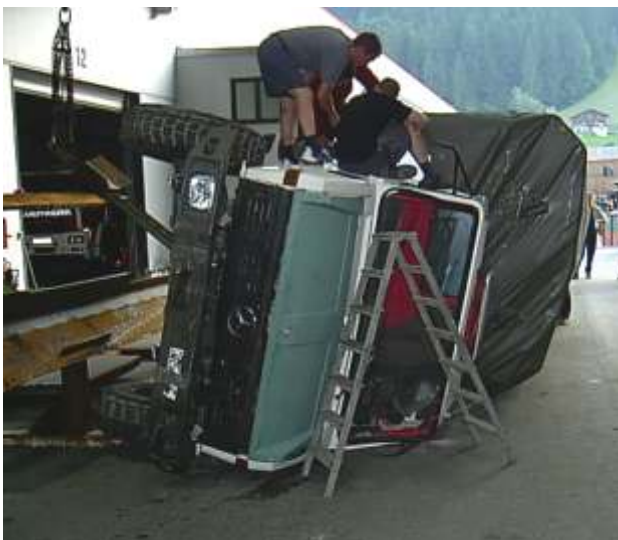
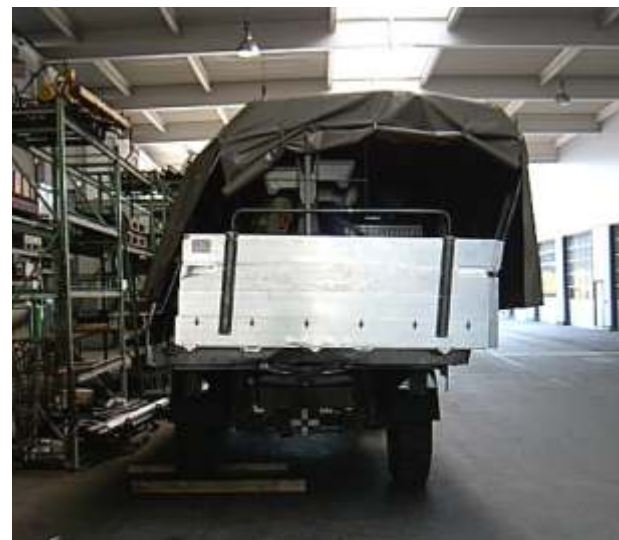
Fig. 16 - 21: Test 2 – Procedure

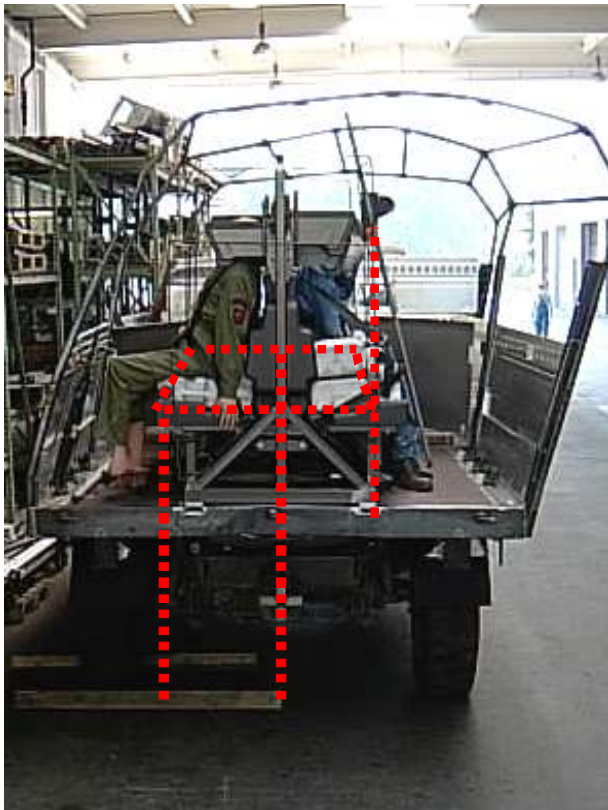
Fig. 22: Undamaged Survival Space

- The connection elements between
 - Chassis & torsion free subframe
 - Subframe & interchangeable body
 - Floor of platform body & Safety seat modulewere 100% stable
- The EMPL safety seat module
no damage
- The assault rifles
remained in the destined fittings (Fig. 22)
- Damages within expected bounds

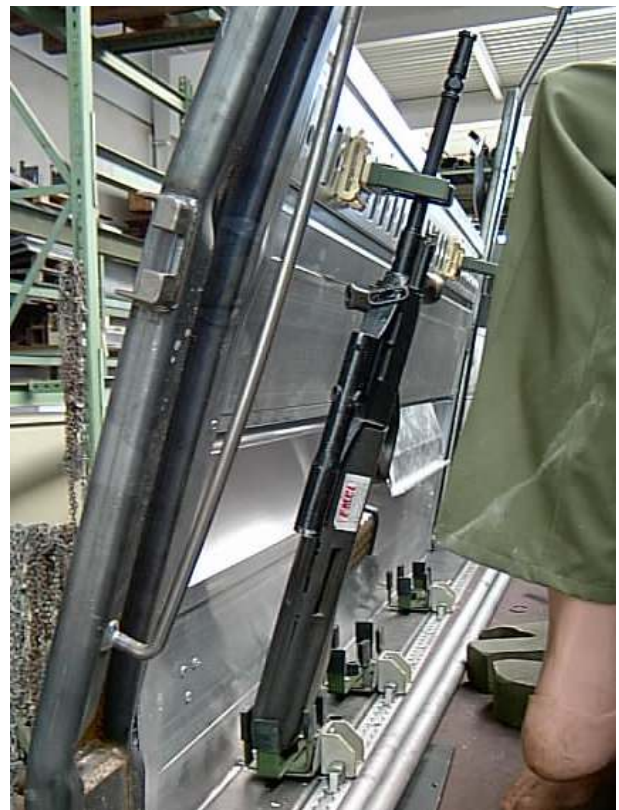
Fig. 23: Assault rifles remained in fittings

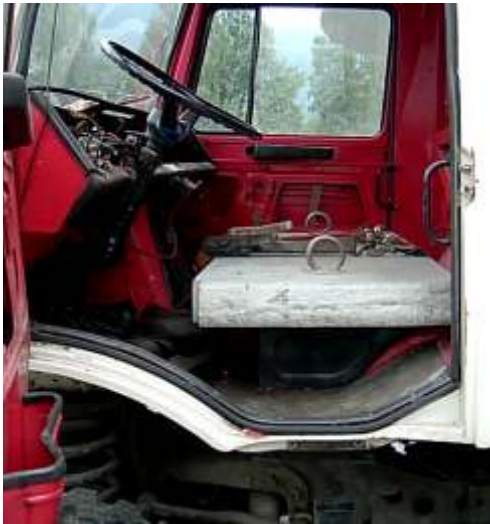
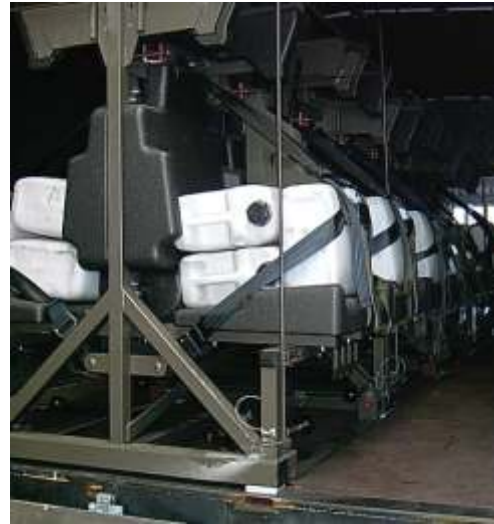
Fig. 24+25: Test 3 - Fully laden Chassis and Platform Body

The fully laden UNIMOG (Fig. 24+25) is tilted side way (Fig. 26) and consequently starts rolling down a steep hill (Fig. 27-32).

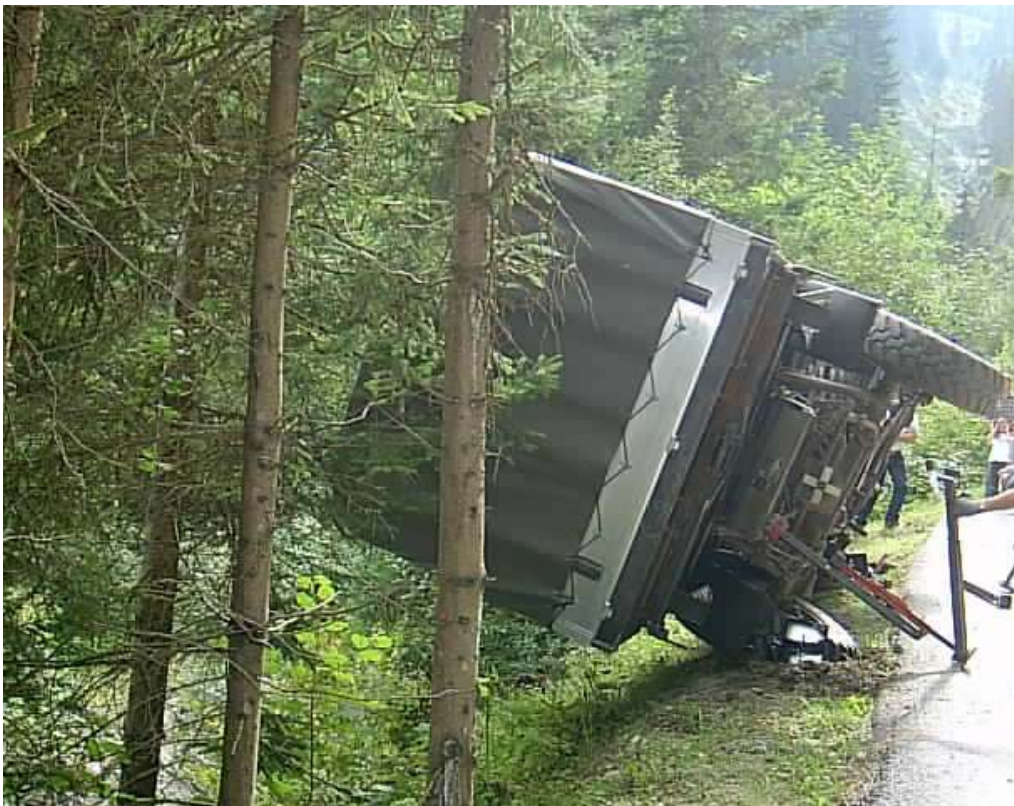
Fig. 26: Test 3 - Test Arrangement

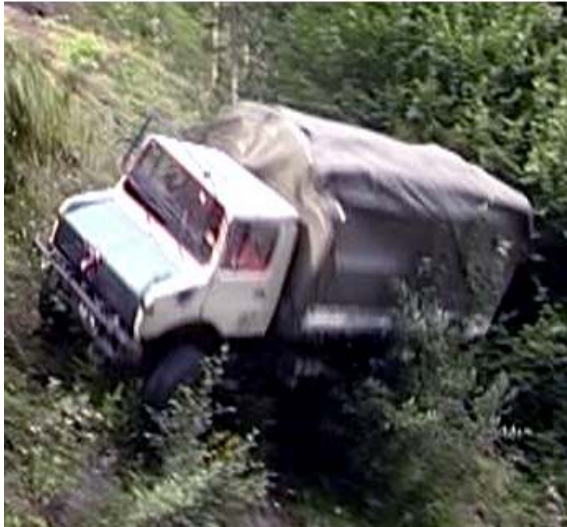
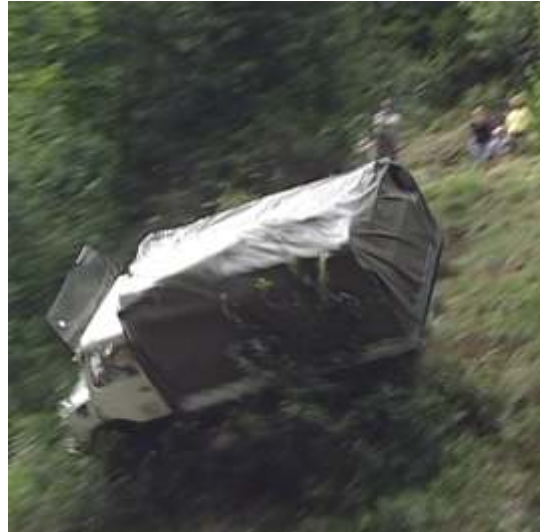
Fig. 27+28: Vehicle after 1st rollover (phase 1)

- Phase 1 - after 1st rollover (Fig. 27+28)
No substantial damages after 1st rollover.
- Phase 2 - 2nd collision after free fall (Fig. 29+30)
After the vehicle crashed with the top ahead and in free fall on the nearly horizontal river bank, the driving cab deformed massively, whereas only some parts of the body deformed slightly. (as e.g. the seat module at the very front)
- Phase 3 - 3rd collision on the opposite hill (Fig. 31+32)
The following crash on the opposite hill caused all of the ballast weights, fastened in the driving cab, to be catapulted out as well as some of the ballast containers (à 25 kg), mounted on the seat modules. Moreover, the collision caused deformation of the seat module at the rear. (Fig. 34)

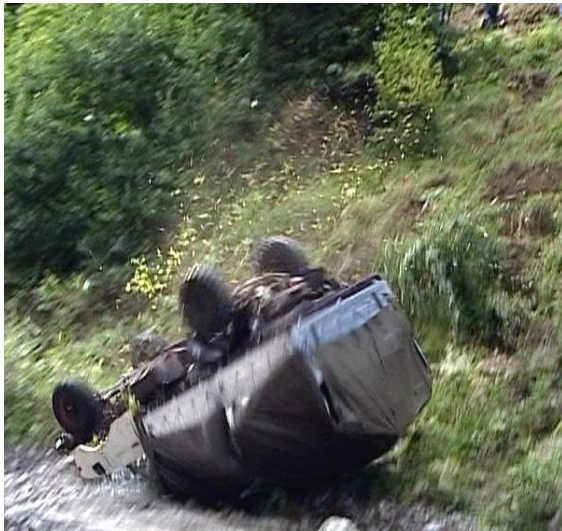
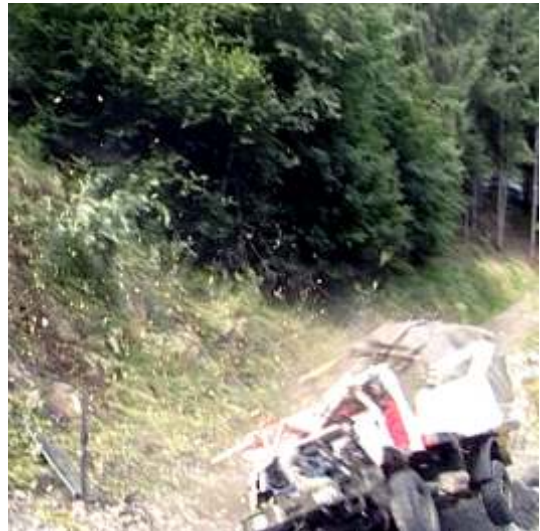
Fig. 29+30: Vehicle after free fall crash (phase 2)

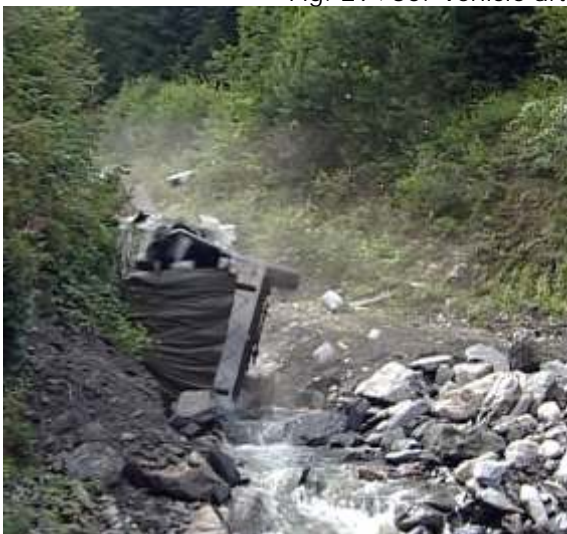
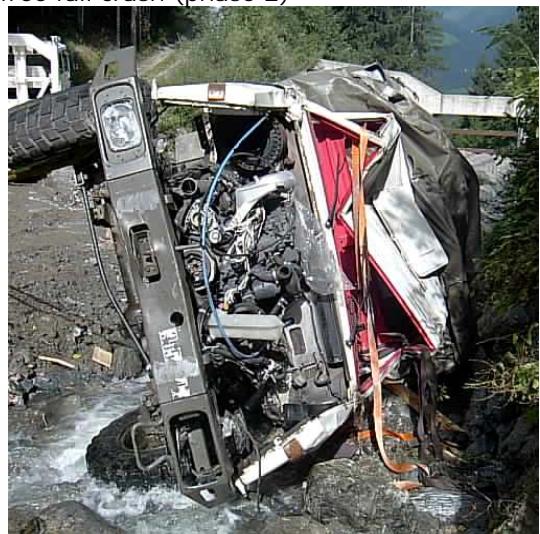
Fig. 31+32: Vehicle after crash on opposite hill (phase 3)

- Results
 - The vehicle overturned 2,5 times before crashing into the opposite hill and came to a rest in the river.
 - The procedure of the test was as expected.
 - All 4 elements, connection the platform with the subframe, resisted major forces and were not damaged. Only slight deformation was detected. (Fig. 33)
 - Only the safety seat modules at the very front and the rear of the platform were deformed between 280 mm and 430 mm. The two modules in the middle remained intact. (Fig. 34)

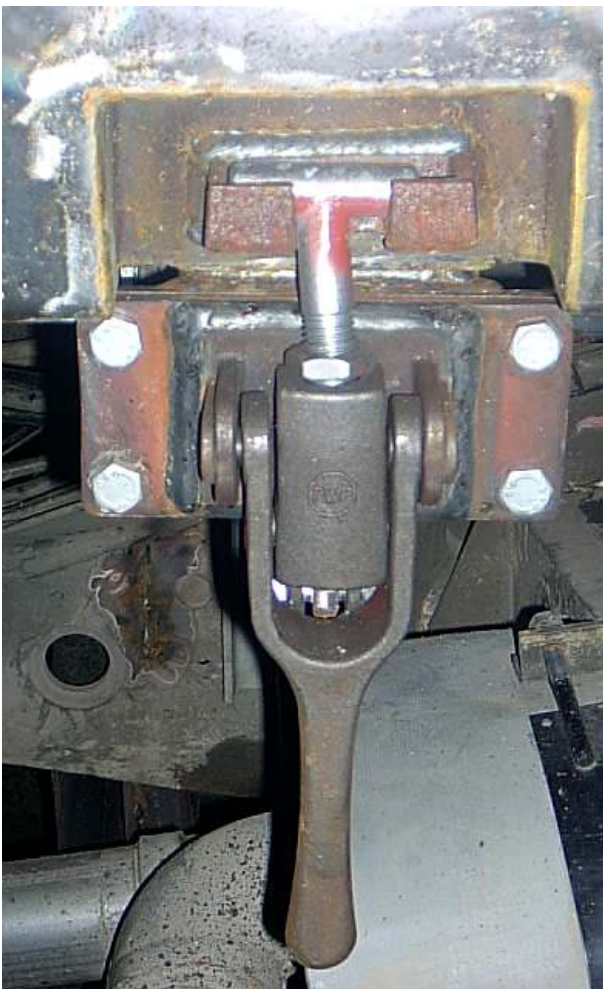
Fig. 33: Undamaged locking mechanism

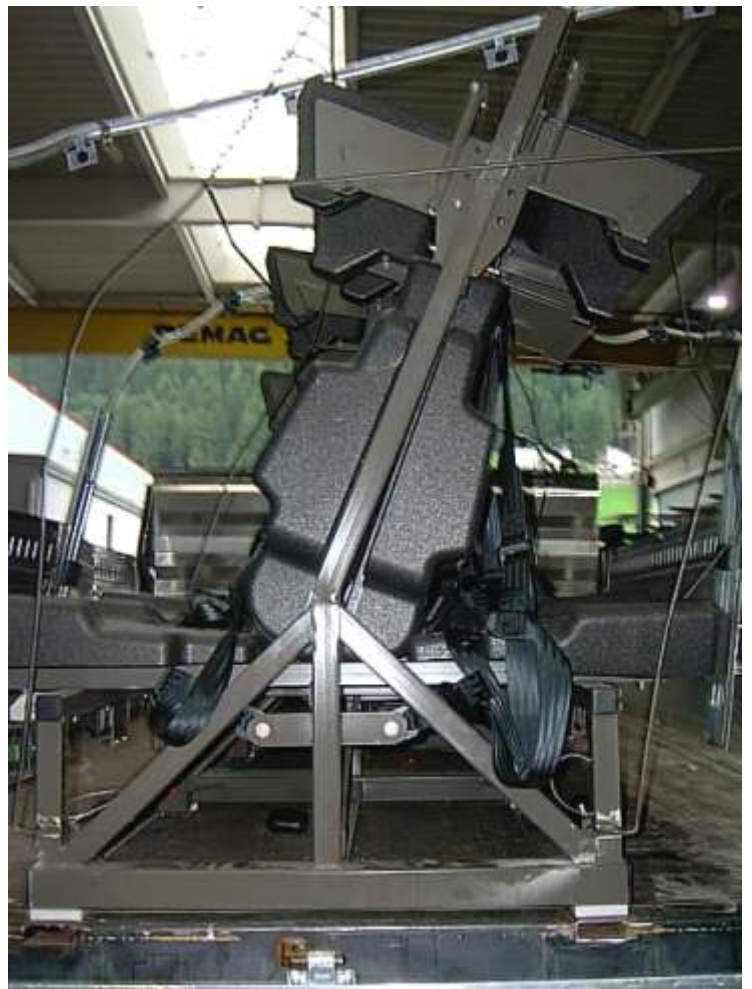
Fig. 34: Safety seat module at the rear

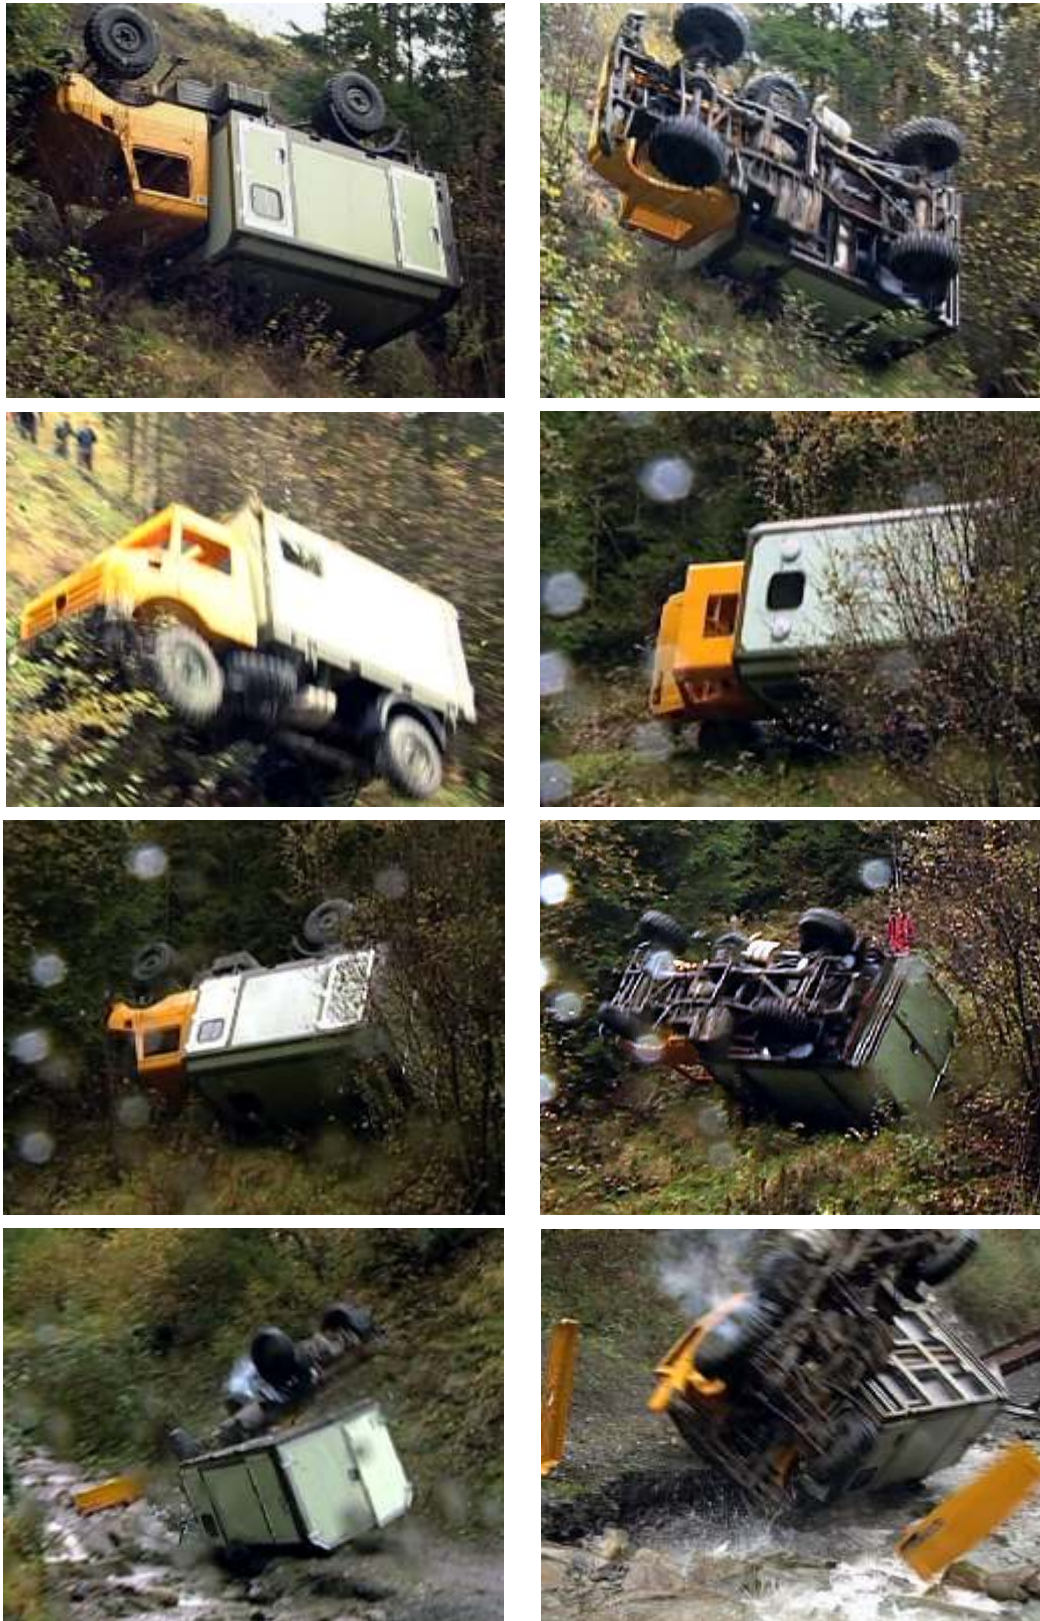
Fig. 35-42: Rollover a Van Type Body
